ANNUAL REPORT

ARCHÆOLOGICAL DEPARTMENT

SOUTHERN CIRCLE, MADRAS

1915-1916

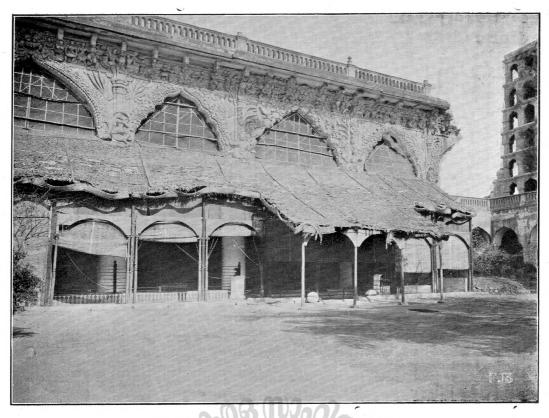
PLATE XVI (a)

The Nayak's Durbar Hall, Tanjore Palace. (Before Repairs.)

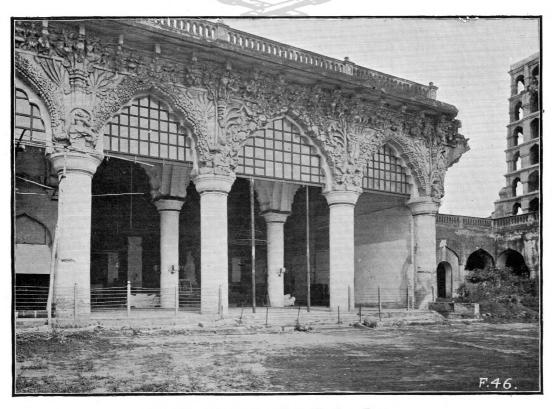
PLATE XVI (b)

The Nayak's Durbar Hall, Tanjore Palace. (After Repairs.)

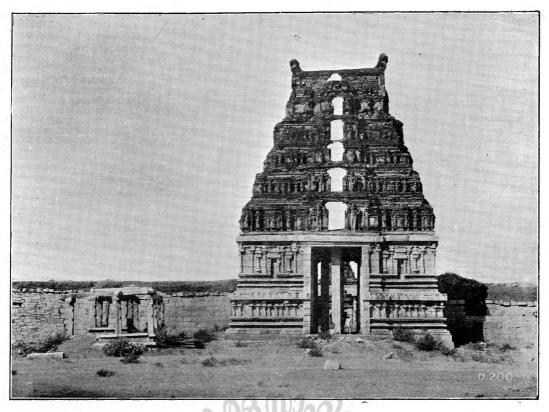
PLATE XVII (a)

East Gateway of the Pattabi Rama Temple, Vijayanagar, Bellary District. (Before repairs.)

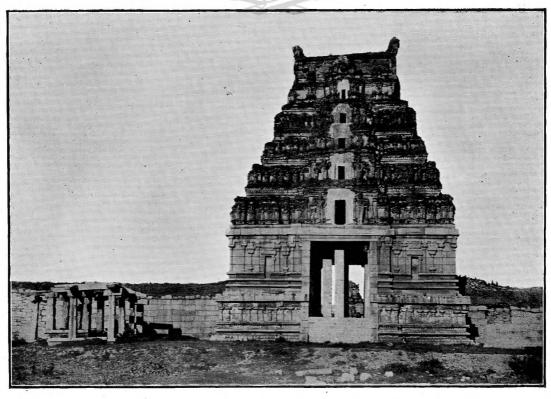
PLATE XVII (b)

East Gateway of the Pattabi Rama Temple, Vijayanagar, Bellary District. (After repairs.)
